# **FOREDUNE CLASSIFICATION AND STORM RESPONSE: AUTOMATED ANALYSIS OF TERRESTRIAL LIDAR DEMS**

KATHERINE L. BRODIE<sup>1</sup>, NICHOLAS J. SPORE<sup>1</sup>

1. *U.S. Army Engineer Research and Development Center, Coastal & Hydraulics Laboratory, Coastal Observation & Analysis Branch, 1261 Duck Rd, Duck, NC 27949, USA. [Katherine.L.Brodie@usace.army.mil](mailto:Katherine.L.Brodie@usace.army.mil); [Nicholas.J.Spore@usace.army.mil](mailto:Nicholas.J.Spore@usace.army.mil)*

**Coastal Sediments 2015 – San Diego, CA  
“Understanding and Working with Nature”**

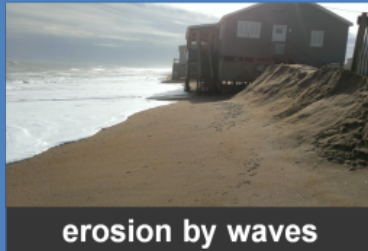
### Coastline Dynamics

- erosion by waves
- geologic framework
- sediment supply
- storm magnitude/frequency
- beach/nearshore morphology
- barrier island response to sea level rise

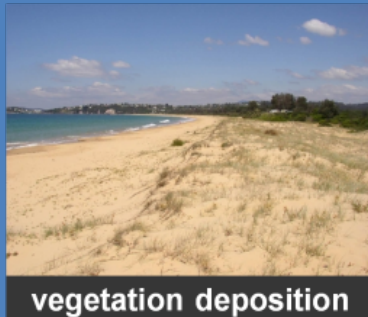
### Aeolian Processes

- fetch-controlled sediment supply
- wind speed
- sediment size & type
- vegetation
- moisture content

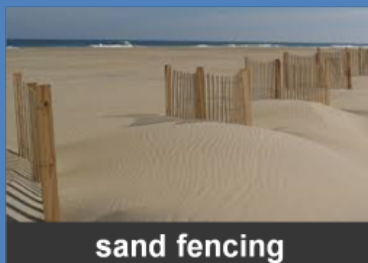
### Management

- anthropogenic sediment supply
- dune engineering
- planting vegetation
- sand fencing
- beach nourishment
- engineering structures

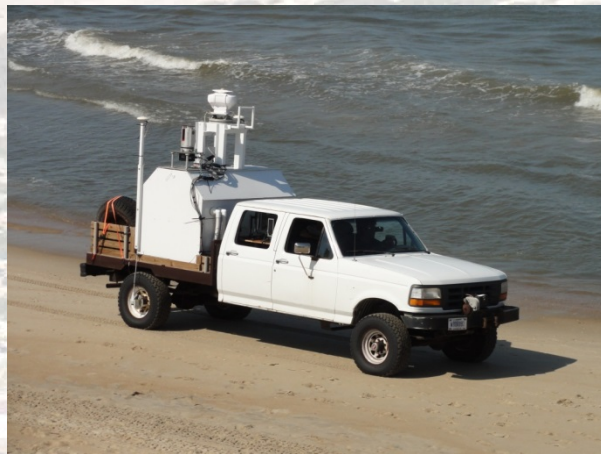
Coastal Lidar and Radar Imaging  
System (CLARIS)

- Mobile terrestrial lidar surveys performed daily along 11km stretch of coastline during 6-day Nor'easter
- Coupled with X-band radar to produce time-averaged images of radar intensity (i.e. wave breaking)
- Centered around low-tide for maximum foreshore exposure and personnel safety
- Largest waves on March 10:  $H_s = 4.8$  m at 16 sec

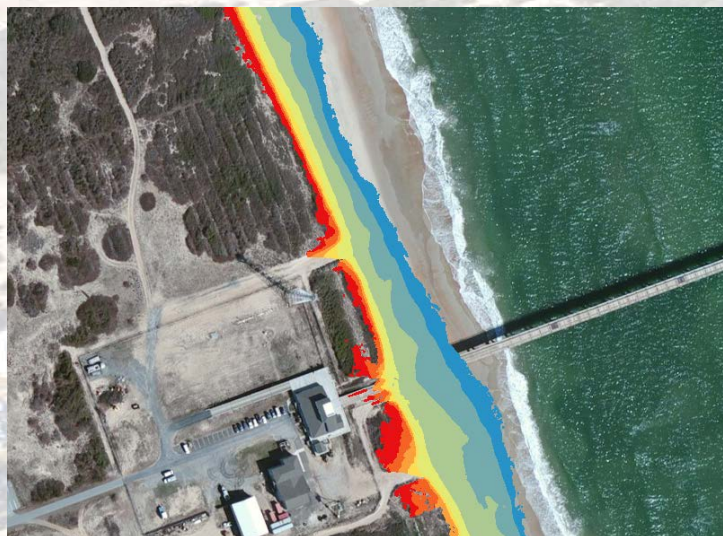
2. Bare-earth DEM at 50 cm resolution
